NBS BUILDING SCIENCE SERIES 94

Investigation of the Skelton House Collapse
in Fairfax County, Virginia

Investigation of the Skyline Plaza Collapse in Fairfax County, Virginia

NBS Building Research Institute, Inc. 34
Edgar V. Leyendecker and S. George Fattal

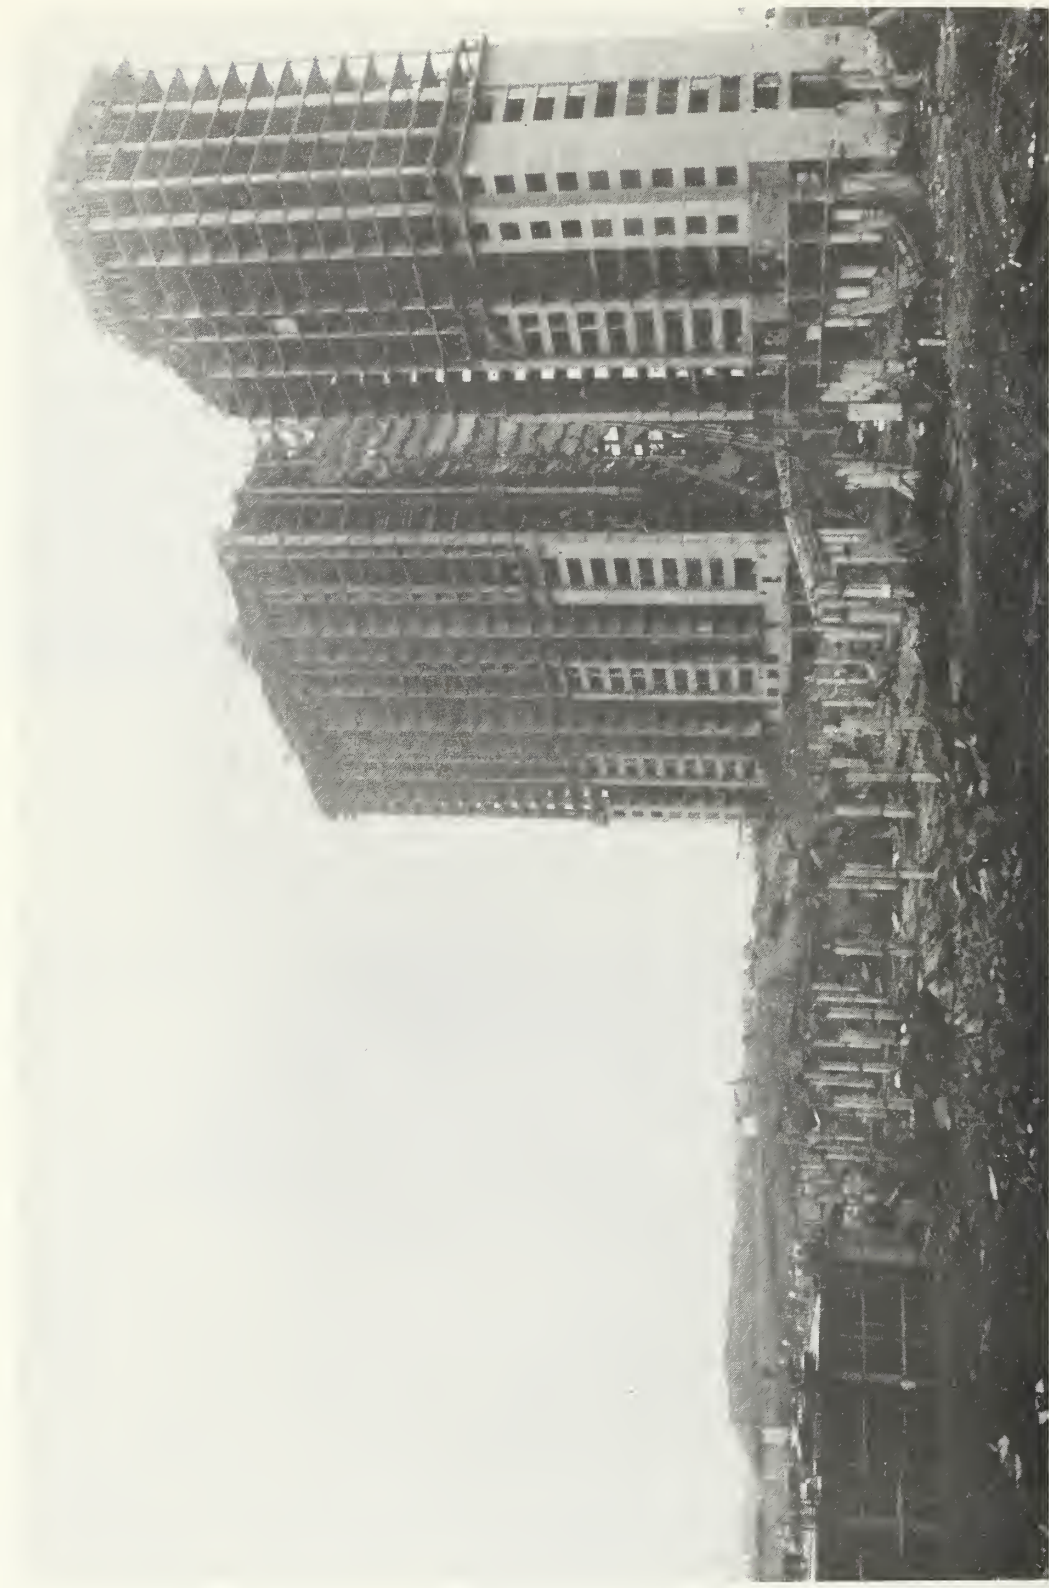
Figure 1.3 Appearance of the collapsed structures as viewed from the southeast.

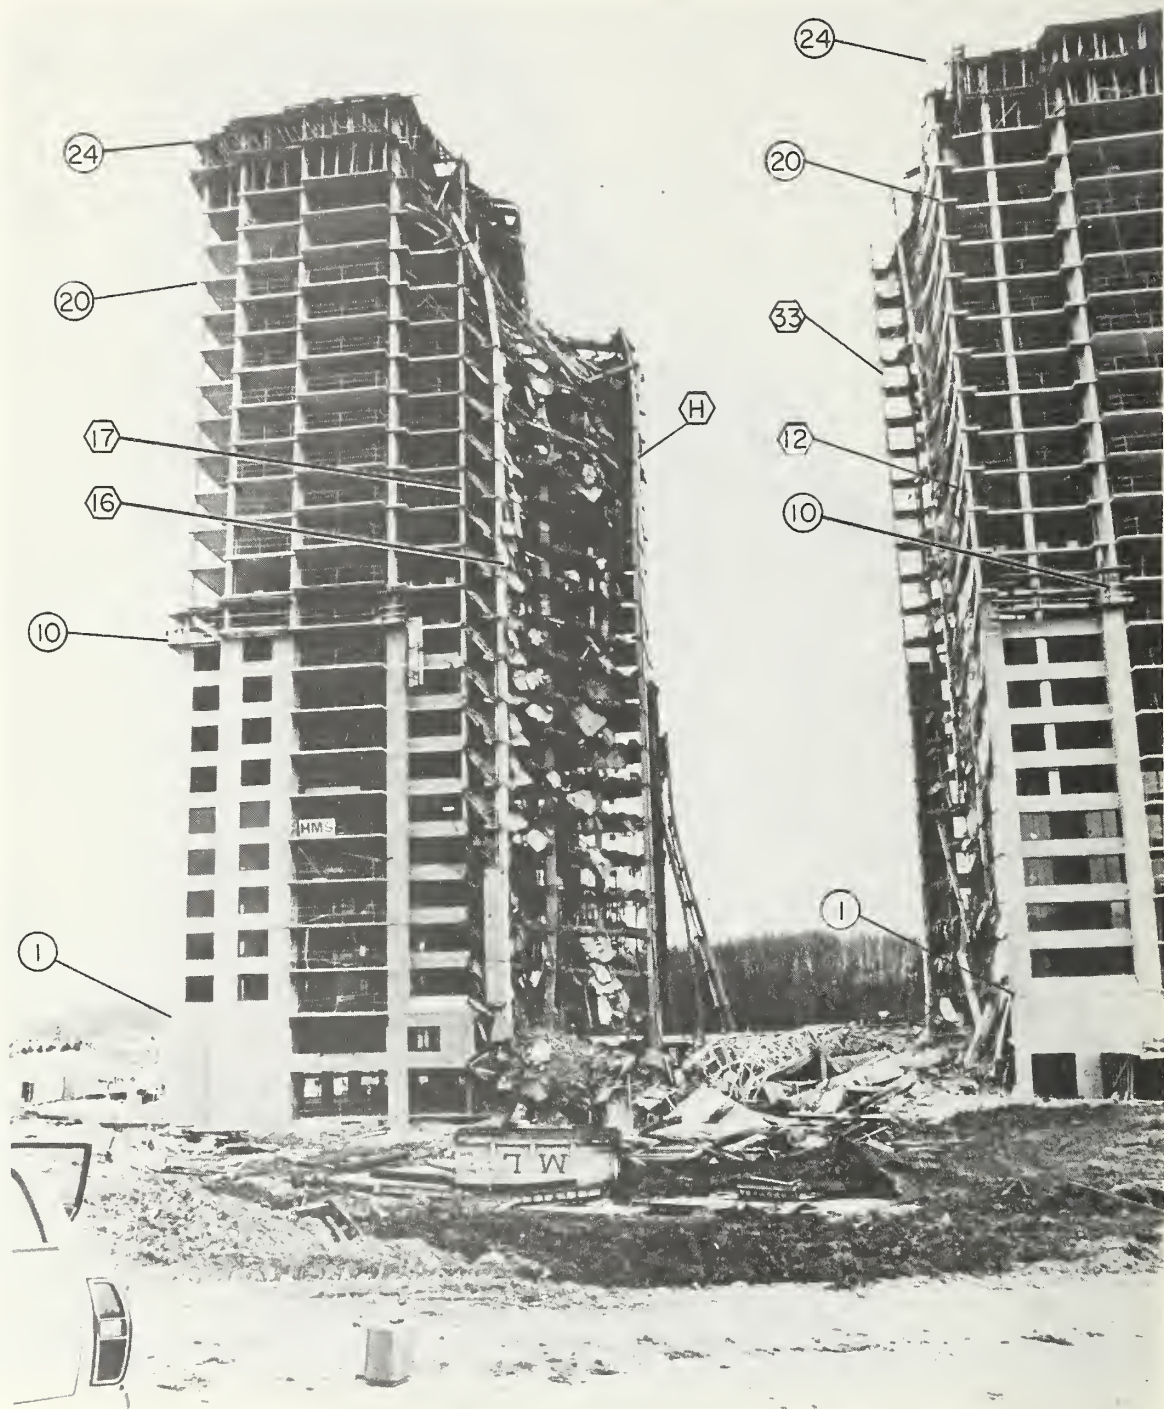
A partial view of the north face of building A-4 is shown in figure 2.5. A number of columns and floors are identified. The collapse extended between shear wall H and column 33 on the south face, a distance of about 65 ft (refer to figure 2.1). On the north face the collapse extended between columns 12 and 17, a distance of about 104 ft. Note that for most floors the slab between columns 16 and 17 did not sever from the main building but is sagging for a one-story height. Below the 20th floor, the horizontal extent of the collapse is as discussed above. Above the 20th floor, the failure zone extended slightly to the west and a greater amount to the east.

Figure 2.5 General view of the north face of building A-4.

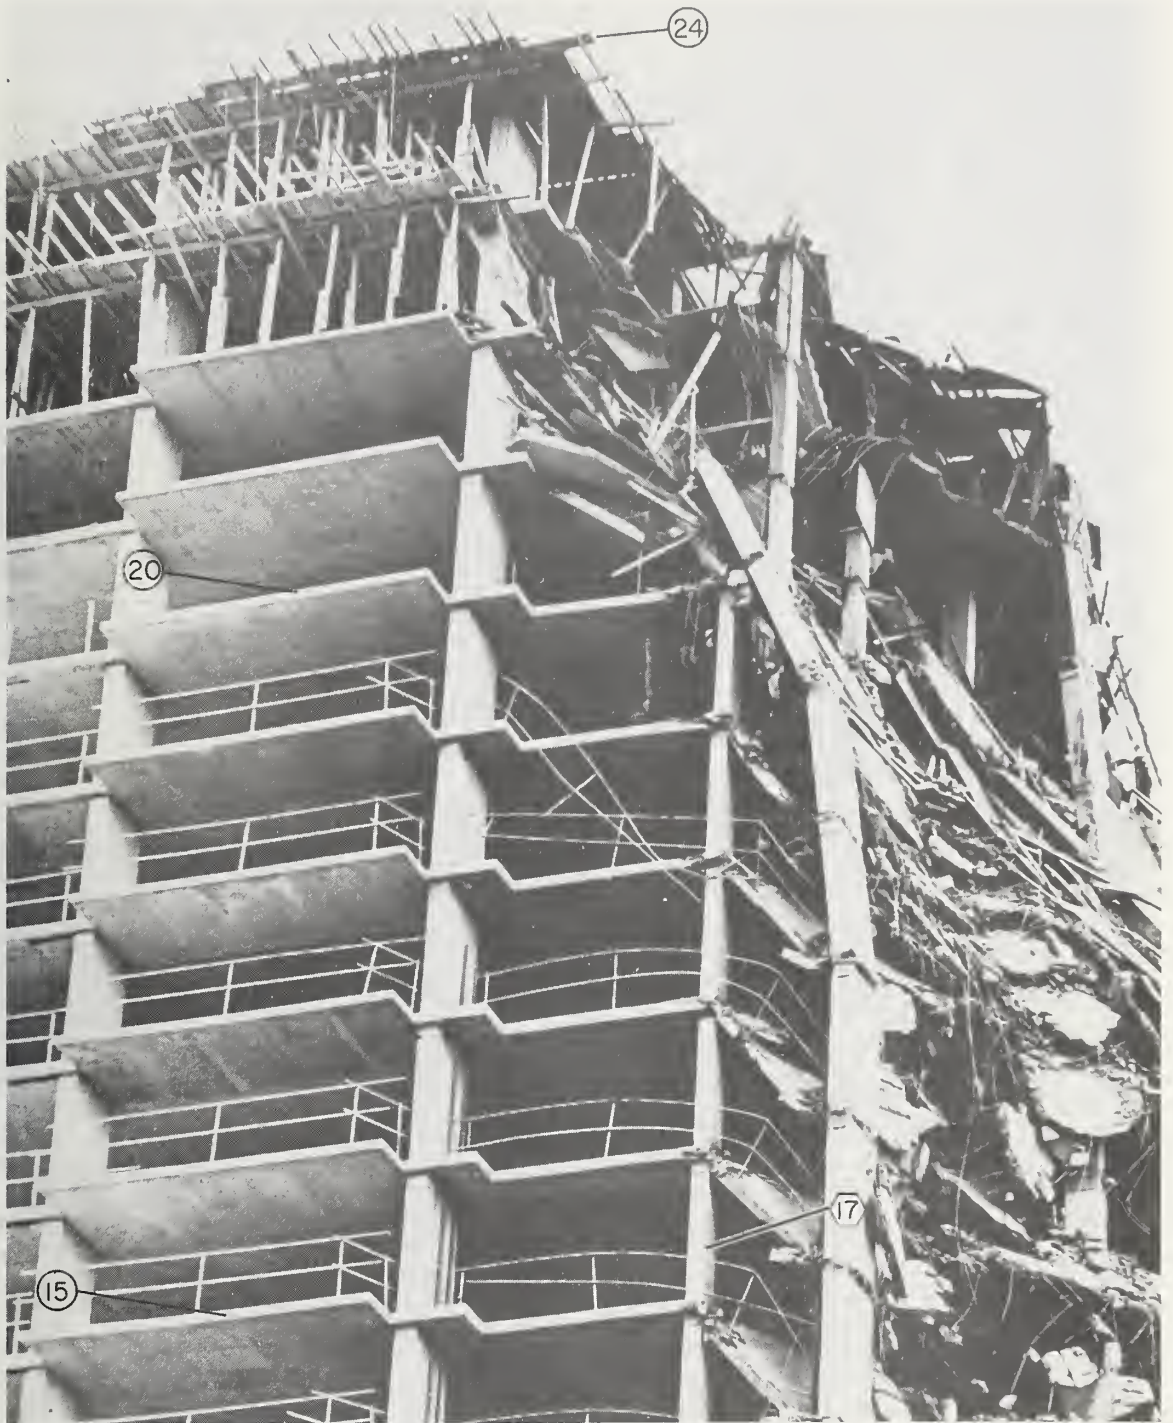
Figures 2.6 through 2.8 are closeup views of the east end of the failure zone. These figures require little comment at this time; however, it should be noted that the formwork is clearly visible in figure 2.6.

Figure 2.6 Closeup view of the top of the east end of the failure zone, looking south.

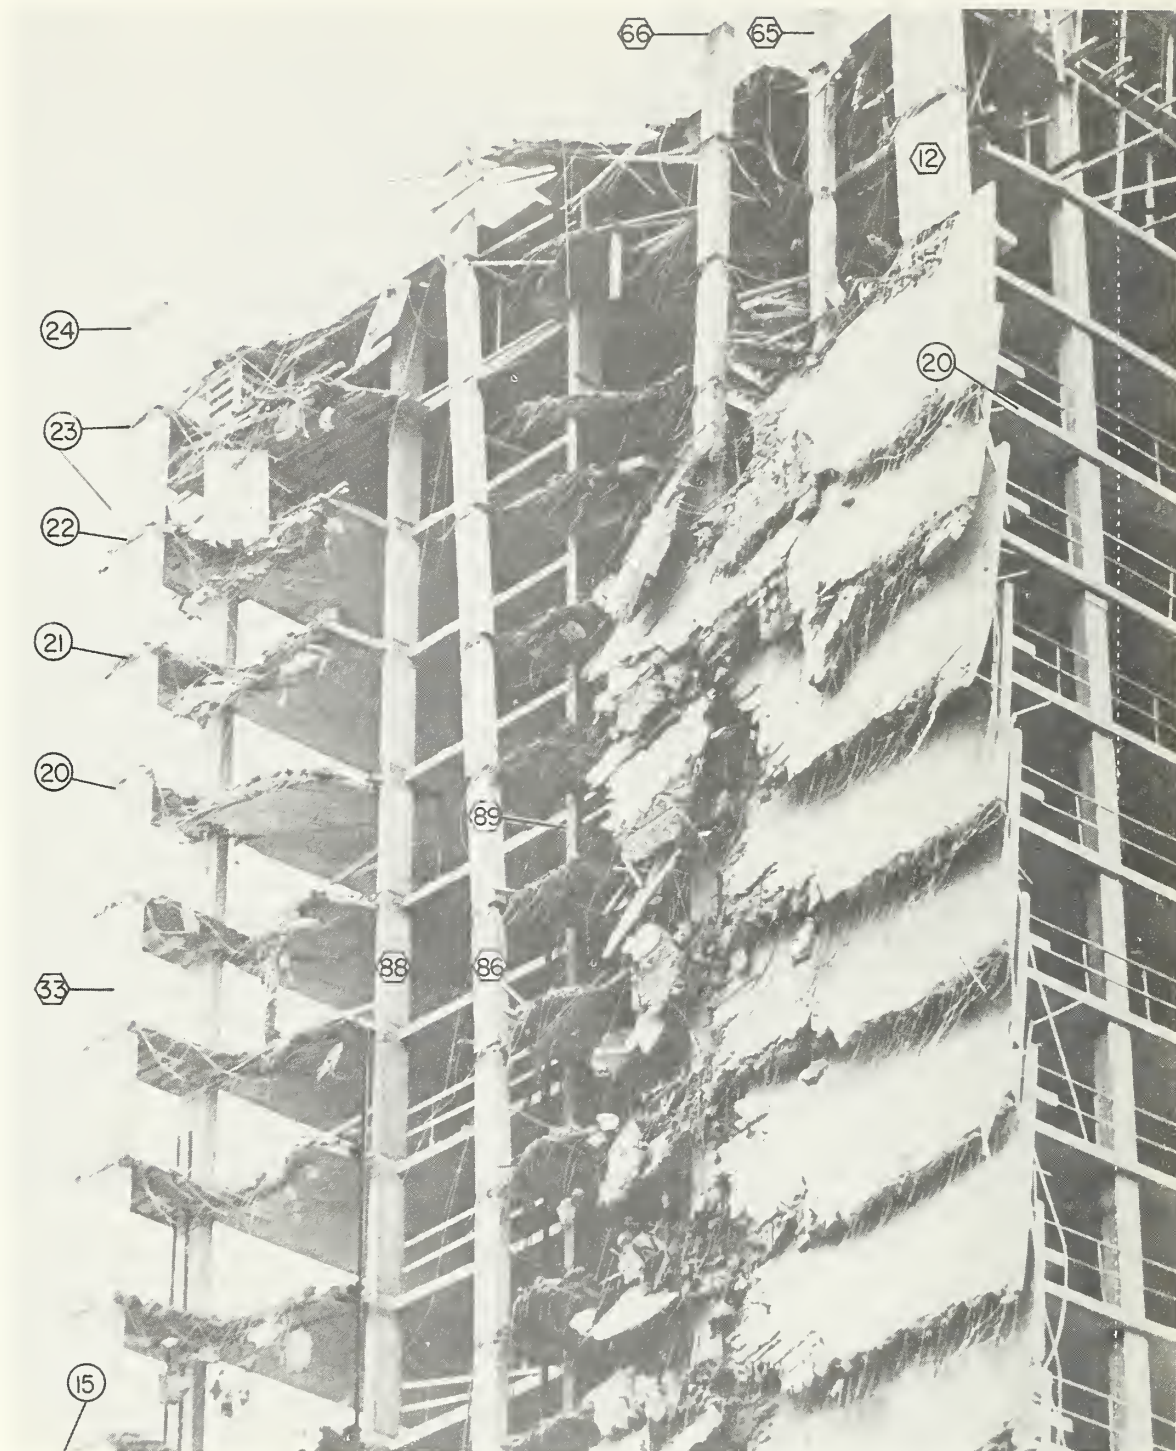
A general view of the west end of the failure zone is shown in figure 2.9 along with closeup views in figures 2.10 through 2.12. These figures also require little comment at this time; however, it should be noted that the formwork is clearly visible in figure 2.10.

Figure 2.10 Closeup view of the top of the west end of the failure zone, looking southwest.

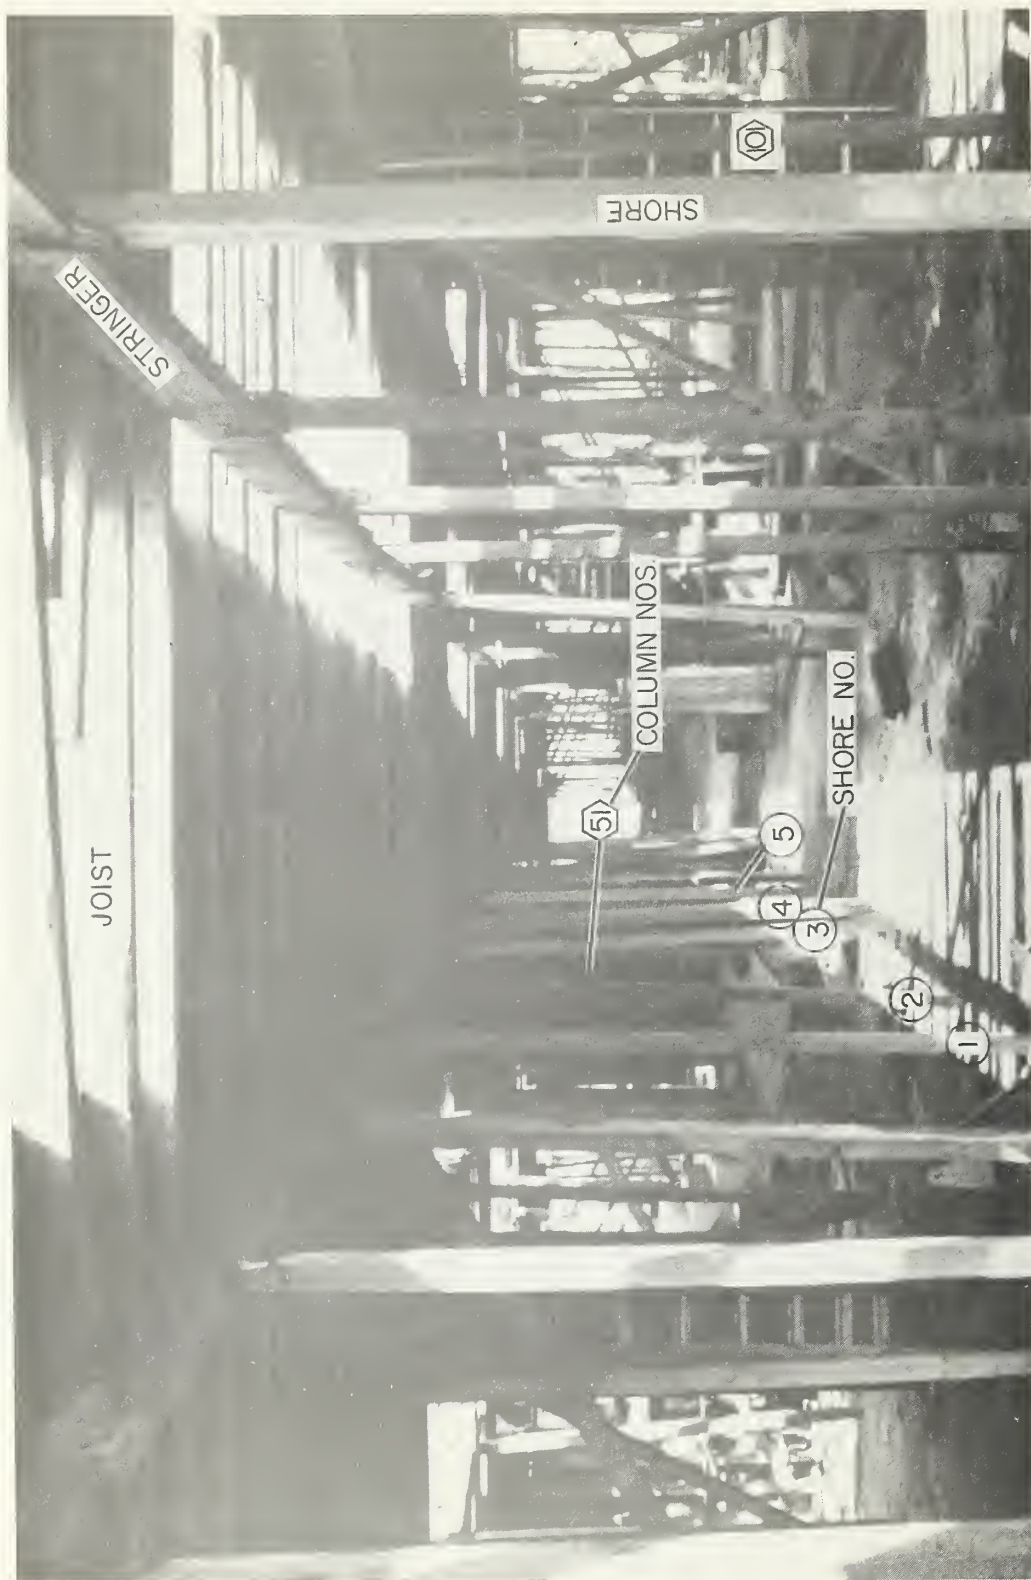
Figure 2.16 Formwork in sections 1 and 2 of 24th story, looking east.

As may be seen in figure 2.16, the stringers were placed east-west and the joists were placed north-south. Employee statements indicate that stringers and joists were usually 16 ft in length although some were as short as 6 to 8 ft.

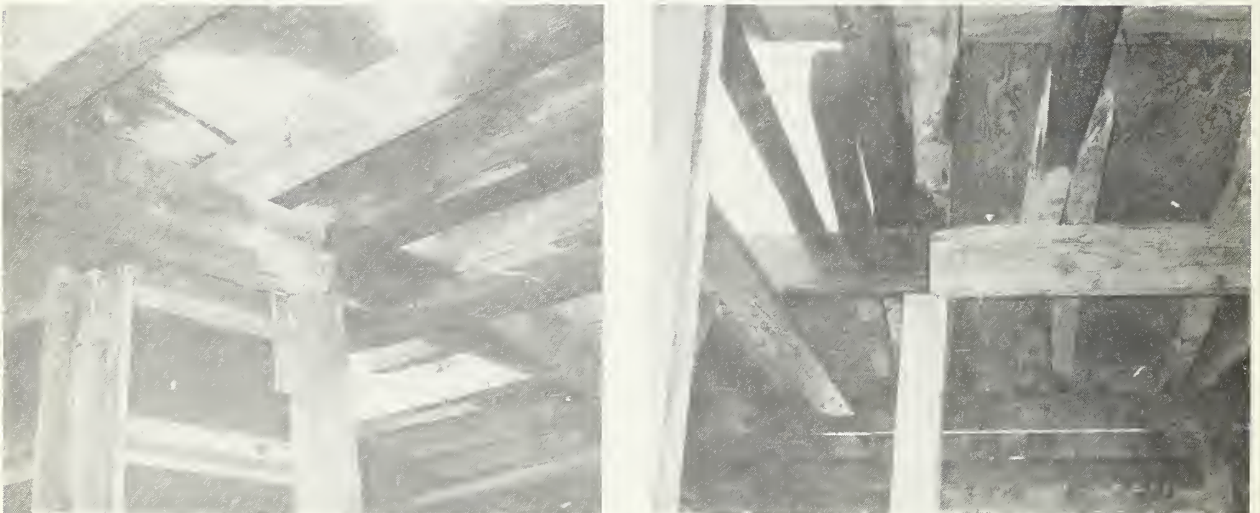
During the NBS site inspection, a considerable portion of the lumber used for the remaining forms in the 24th story was found to be in poor condition or out of plumb. For instance, the top photograph in figure 2.18 shows a stringer with a battered end directly over the shore. The second photograph illustrates a shore which is out of plumb and has a vertical crack near the top. OSHA regulations (ANSI-A10.9, sections 8.1.24 and 8.1.25) [2] require correction of both of these conditions prior to placing concrete (which was not yet placed on these forms).

Figure 2.18 Selected details of 24th story forms.

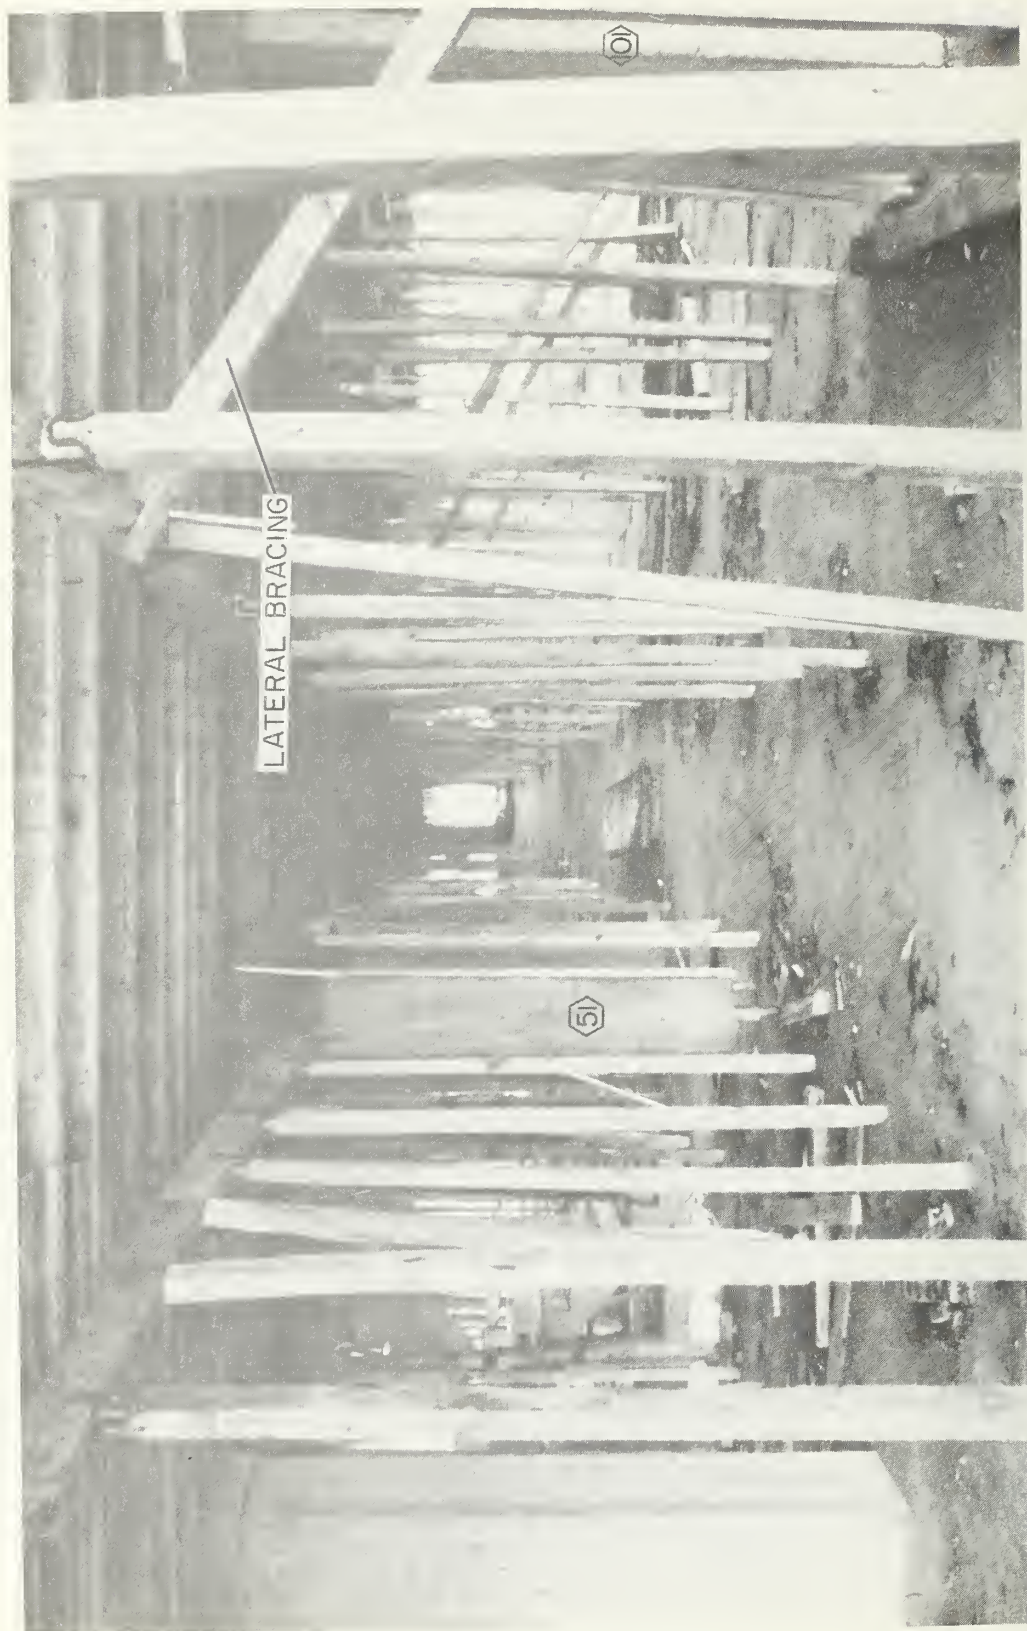
The formwork on the 23rd story is shown in figure 2.20. These forms supported the 24th floor which had been cast on February 28 (section 1) and March 1 (section 2). Note the number of shores out of plumb and the location of lateral bracing. The method of attaching the brace to the stringer may be seen in figure 2.20. The method of attaching the brace to the floor is shown in figure 2.21. A portion of a nominal 3 x 4 was nailed to a piece of plywood which was in turn nailed to the floor. A plywood plate was occasionally used to nail the brace to the nominal 3 x 4. Note the absence of such a plate in figure 2.21. Occasionally, the brace was installed with the plate, in other instances, there was no positive attachment of the brace to the floor. In one case, the plywood stop was not nailed to the floor, providing no lateral resistance.

Figure 2.20 Formwork in sections 1 and 2 of 23rd story, looking east.

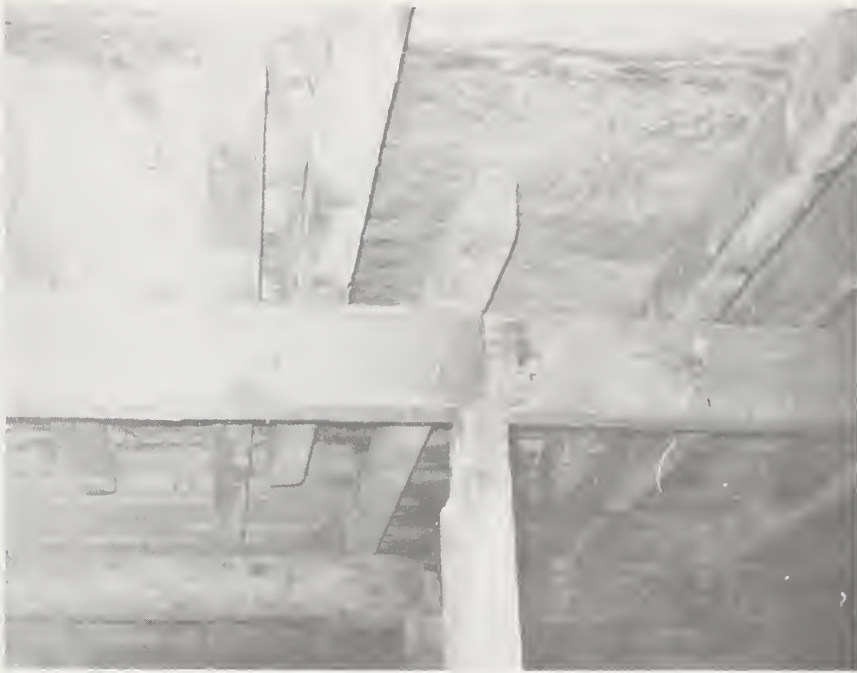
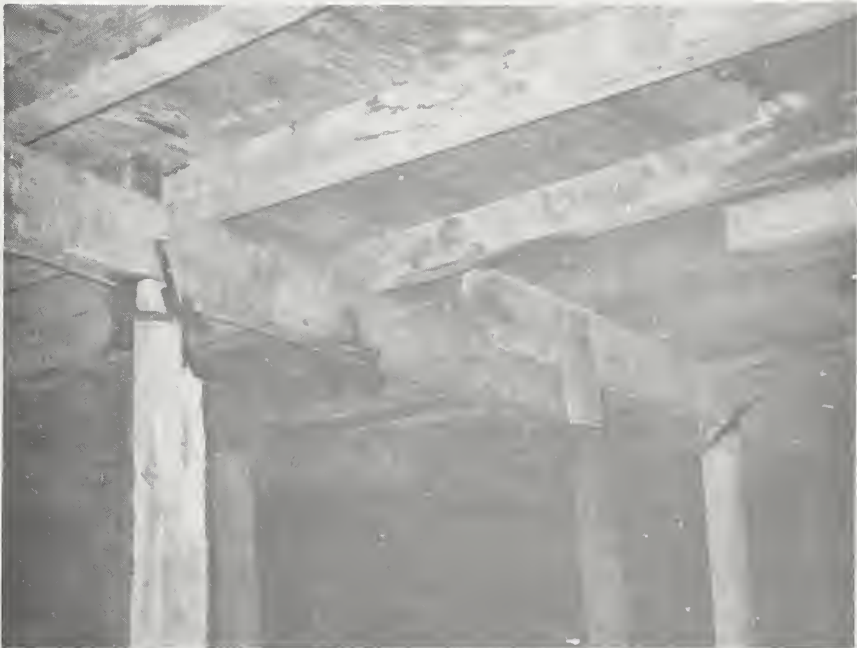
As in the case of the 24th story, the 23rd story lumber which was apparently damaged was reused. Examples of battered shores are shown in figure 2.22. Note the large reduction in bearing area. As in the case of the 24th story, OSHA regulations (ANSI-A10.9, sections 8.1.24 and 8.1.25) [2] required correction of these conditions prior to placing concrete.

Figure 2.22 Selected details of 23rd story forms.

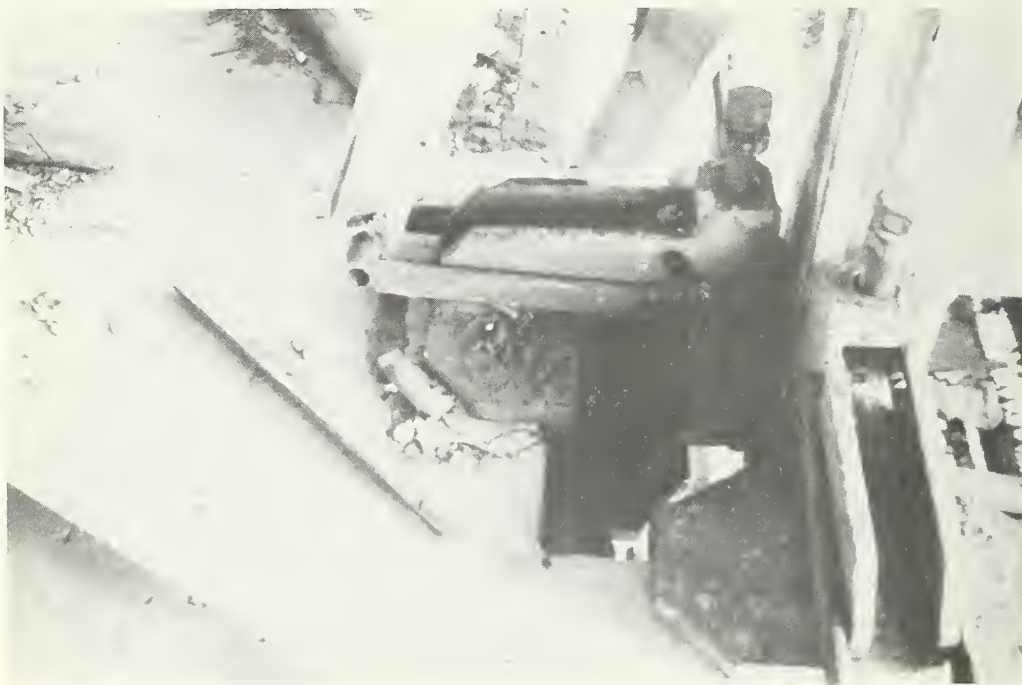
Crane no. 1 was supported by the climbing frame, the lower support, on the 20th floor as shown in figure 2.33. The upper support was provided on the 22nd floor as shown in figure 2.34. This total distance is 18 ft, slightly less than the manufacturer's specified 18 ft 4 in. A typical corner clamp detail on the 22nd floor is shown in figure 2.35. Note the cracked slab where the clamp is attached.

Figure 2.35 Corner clamp detail of upper support.

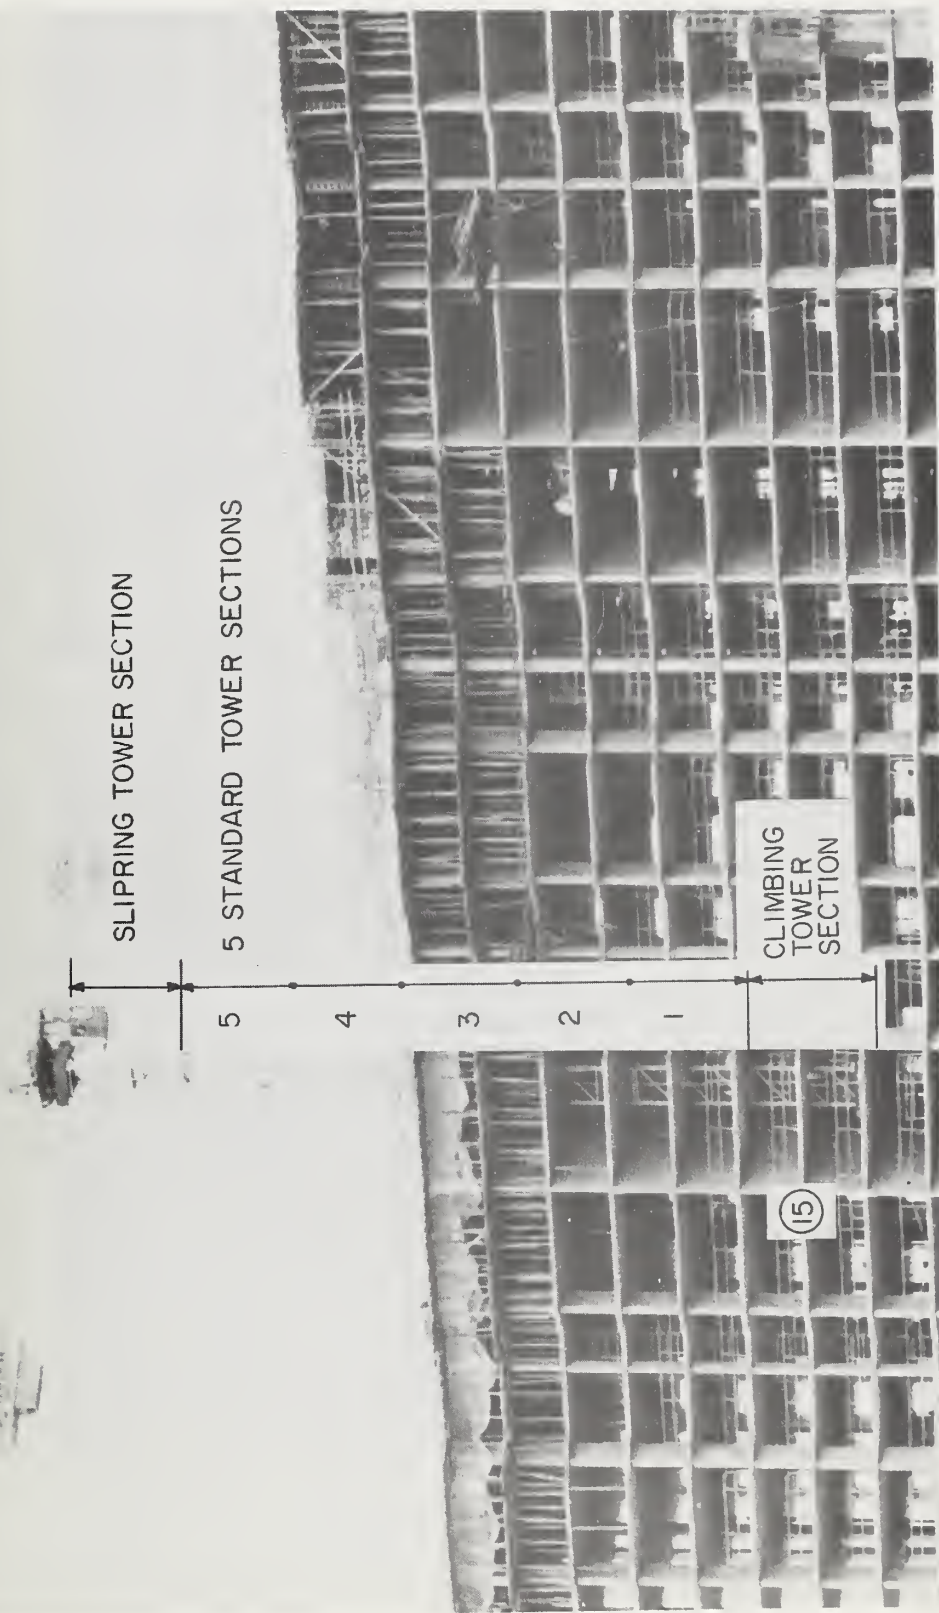
The various tower sections of the crane are identified in figure 2.41. Note that five standard tower sections were used instead of the usual four (figure 2.31 and reference 22). Assuming the upper and lower supports were two stories apart as has been stated, the crane had a free standing height of about 99 ft which exceeds the maximum free height of 81 ft shown in figure 2.31. It is not known if any special precautions were taken to allow the difference between the actual and the recommended installation.

Figure 2.41 Closeup showing crane no. 2 base support.

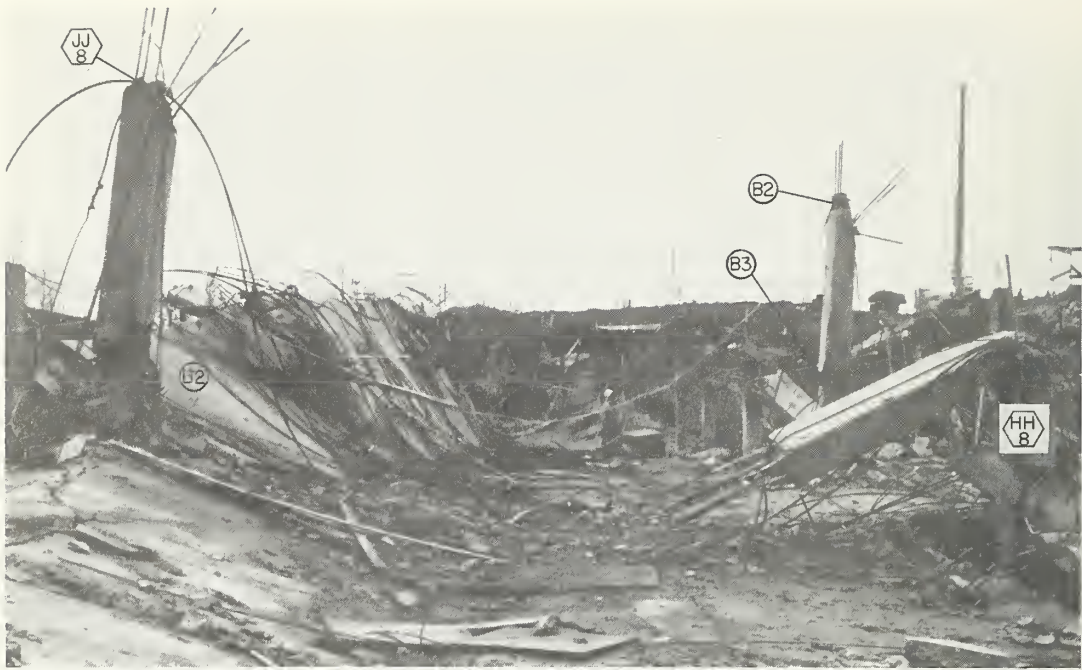
The garage slabs generally came "straight" down except near the slab edges. In the latter cases the columns usually failed in bending. Figure 2.45 shows a view of slab B-2 with the edge between columns JJ-5 and JJ-8 visible on the left. The view of this edge from the south is shown in figure 2.46. Note that the columns failed at the B-3 level. Formwork can be seen lying on top of the slab B-3. These forms apparently were in place under slab B-2.

Figure 2.45 View looking west of slab B-2 between column lines HH and JJ.

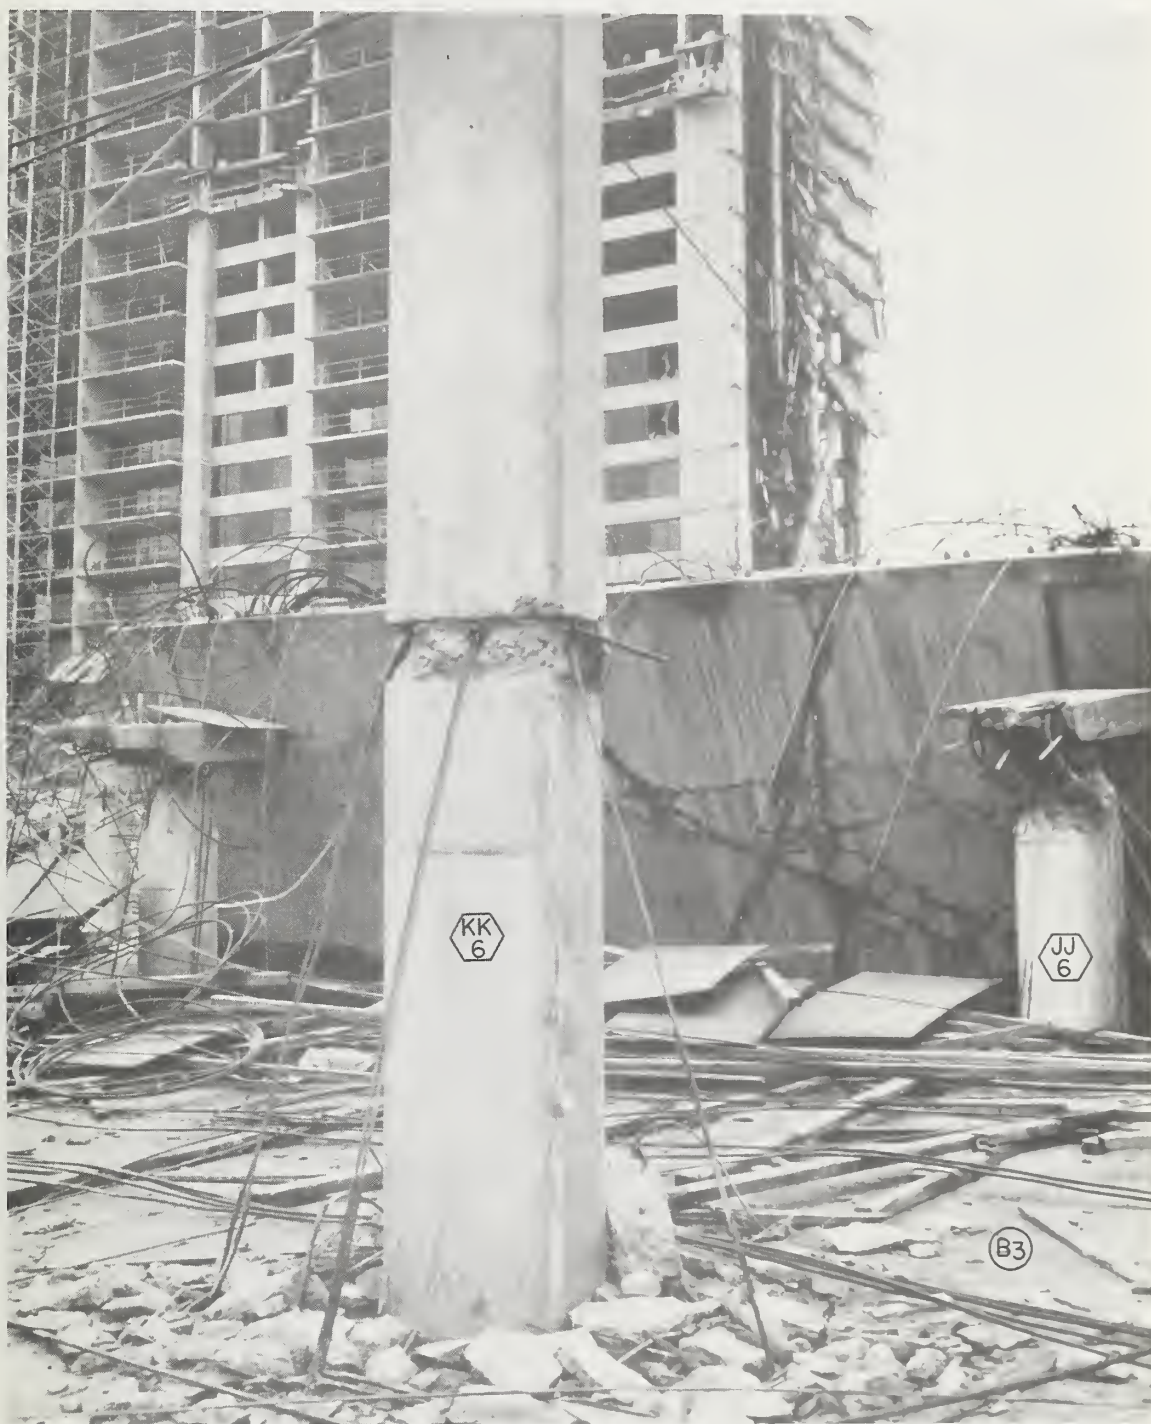
Column KK-6 may be seen in figure 2.47. Once again the shear cone usually associated with a slab punching failure is not visible in the photograph. Note the ruptured reinforcing bars at the base of the column. These are shown more clearly in figure 2.48 (but not for column KK-6).

Figure 2.47 Typical column in the parking garage.

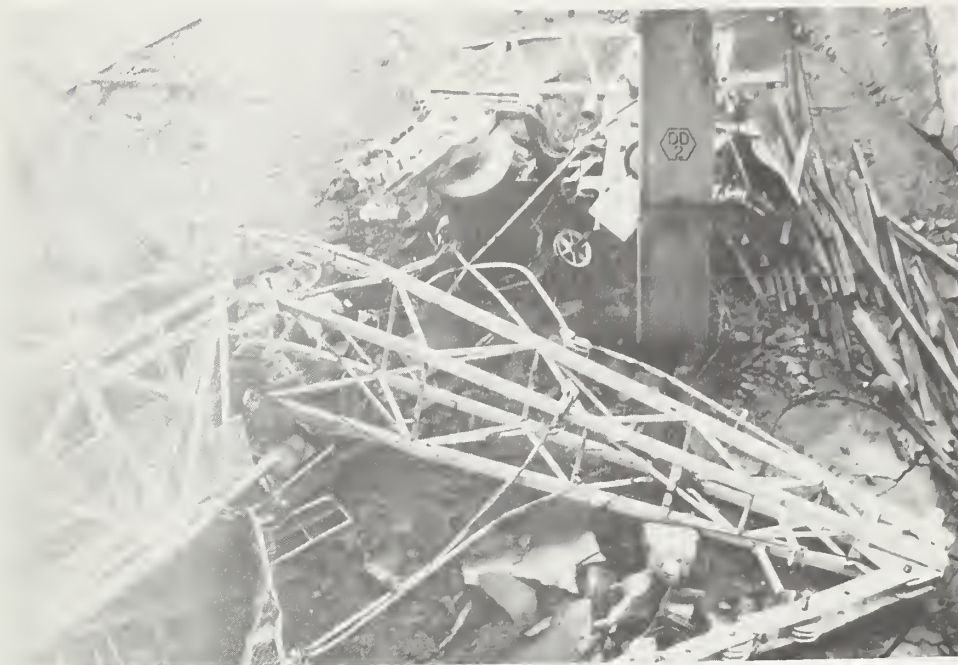
At the time of the collapse, crane No. 2 was reported idle with the jib pointed towards the garage. The exact orientation is not known. A distant view of the tower sections of the crane after the collapse may be seen in figures 2.49 and 2.51 (also 2.5). The tower top and hoist machinery (see figure 2.29) may be seen near column DD-2 in figure 2.55 (Note the partial shear cones on column DD-2). Based on an examination of the photographs it appears (refer to figure 2.1) that the crane tower lines up with the original position of the crane base (in plan view) and passes almost over columns 32 and DD-3, ending up with the top as shown in figures 2.55 and 2.56. This is a total distance of 125 to 130 ft. This distance compares to a total tower height (base section, 5 standard sections, and 1 slipring section) of about 125 ft. The implication here is that the tower fell while rotating about its original plan position. However, careful inspection of figures 2.54, 2.55, and 2.5 shows the jib is lying alongside the tower sections. The sequence of falling which would permit a jib initially pointing over the garage (as reported by employees) to assume its final position has not been determined.

Figure 2.55 Position of fallen crane near column DD-2 looking south.

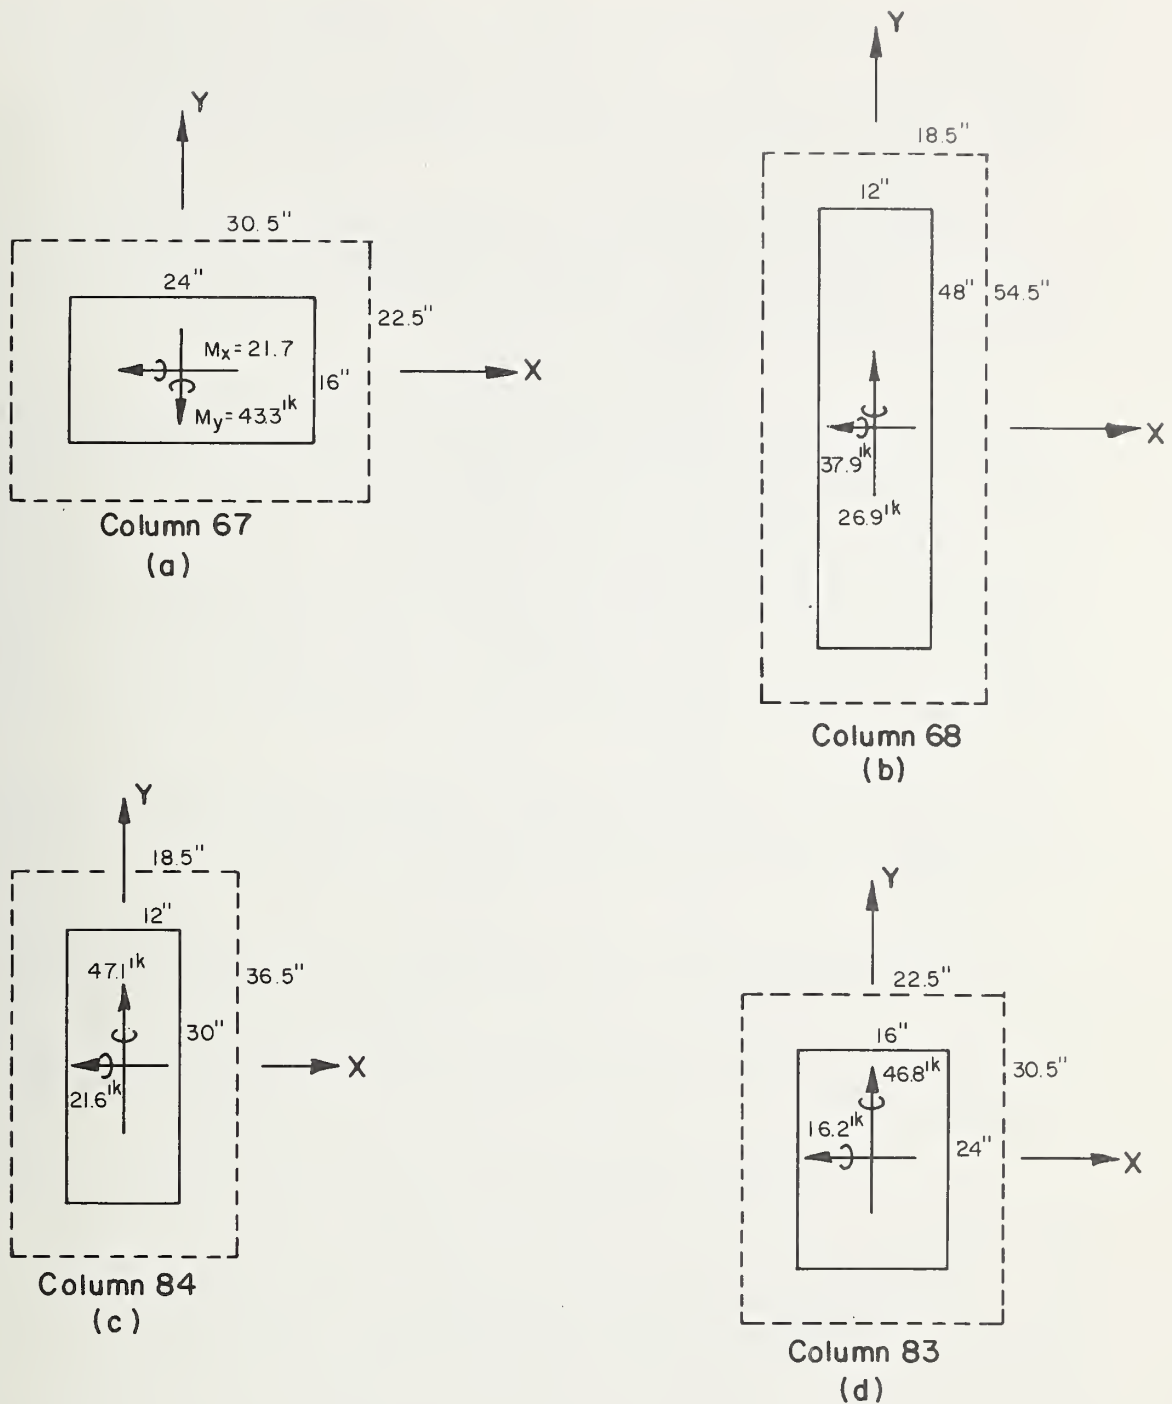
From the analytical results, axial loads and moments transmitted to column elements from the floor system were assessed in relation to peripheral column dimensions in order to establish which of the columns would be expected to create a severe shear condition in the slab. Figure 4.12 shows the four most critical regions identified at columns 67, 68, 83 and 84.

Figure 4.12 Critical section for shear in the slab around columns 67, 68, 83, 84.
